**Magicard: Error code 25:00 Magicard Tri LED
Calibrate Failed – test and solution**

Reward-It Ltd

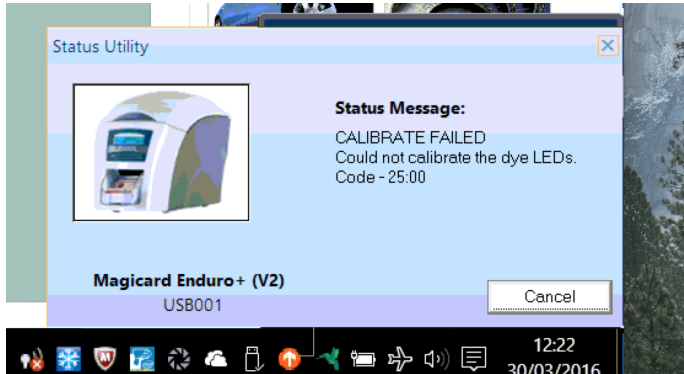
A common fault code that is solved by restarting the printer, cleaning and running a calibration test. If the fault remains then the Tri LED sensor component will need replacing.

There should be a Red, Green and Blue light showing. The fourth will not be lit.

If the LED is not showing all three colours it is faulty and will need to be replaced.

A replacement part should be obtainable from Magicard free of charge.

With a flat headed screwdriver, push the smooth black sloping plastic cover around the LED gently inwards to unclip and then unplug the sensor.

Plug in the new sensor, clip into place and then re-clip the smooth black plastic housing home.
